Silver Brook Watershed Management Plan

July 15, 2009
NJ090193, #71088.0004

Prepared for:
The Great Swamp Watershed Association
568 Tempe Wick Road
Harding Township, NJ 07960

Prepared by:
AKRF, Inc.
100 Centre Blvd., Suite 102H/J
Marlton, NJ 08053

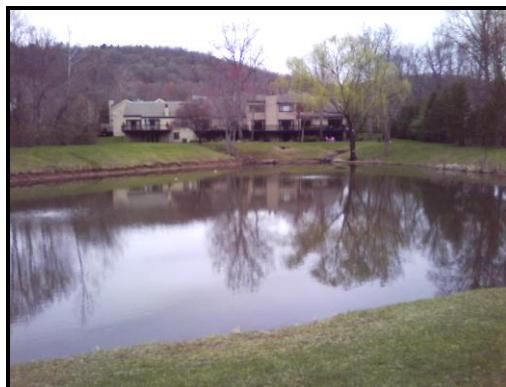
amount of suspended sediment which presumably flows to the receiving channel. To improve settling of suspended solids, the proposed project will retrofit Basin 2 by installing a sediment forebay at the basin inlets, replacing the existing outflow structure with one that retains both small and large storm events, and installing a constructed wetland at the outflow. The proposed project will reduce peak flows and hydraulic energy within the receiving channel, lessening channel erosion and improving water quality.

View of Basin 2.

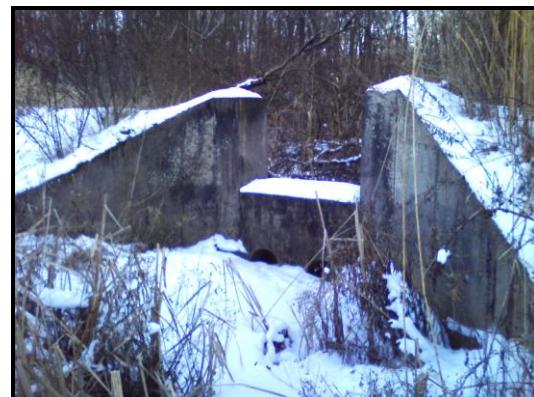
View of outlet structure from Basin 5.

The proposed project consists of converting underutilized sections of the parking lot, particularly those in the vicinity of Basin 5 to native meadow (Project 2a). This will increase the area of pervious cover at the site, providing increased infiltration area for stormwater. The project also includes retrofitting Basins 5 (Project 2a) and 14 (Project 2b) to provide extended detention of water quality and channel-forming flows. The retrofits will involve lengthening the flow path within the basin, naturalizing the basin floor using native vegetation, and adding a water quality orifice to provide extended detention of small storms. Sediment

forebays will be installed at the basin inlets.

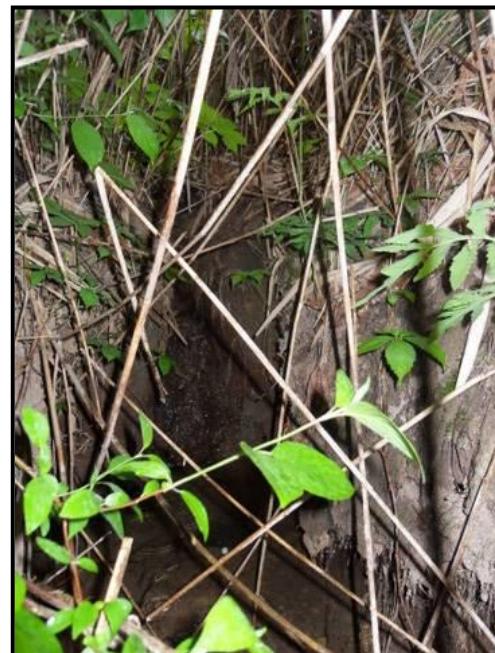
View of headcut at outflow of Basin 19.

The proposed project consists of retrofitting the outflow of Basin 19, stabilizing the headcut located within the small channel downstream of Basin 19, reducing impervious cover on the site, and creating an additional

stormwater treatment facility. This additional facility will consist of a constructed wetland located at the site of the headcut and outflow from Basin 19. The construction of a wetland in this location will stabilize the headcut, preventing further erosion and deposition of sediments with the downstream channels, dissipating concentrated stormwater runoff and providing water quality treatment. The parking lot behind the Church of Jesus Christ of Latter-day Saints includes an additional parking area that appears to be in a deteriorating state, with cracks and vegetation common. The proposed project will replace this parking lot with a constructed wetland that receives runoff from properties along James Street as well as flow from north of I-287. The basin will include a sediment forebay, native vegetation and an outlet structure appropriate to treat both flood and water quality rain events. The areas around the basin will be restored to a native riparian forest.

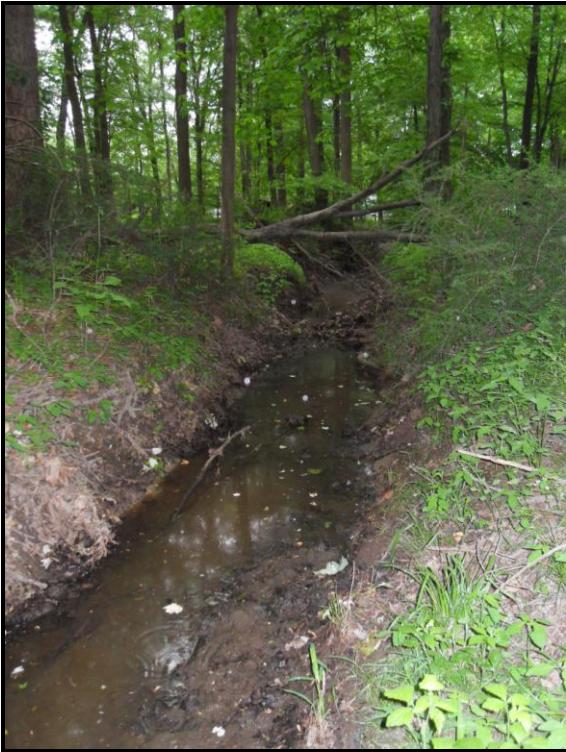
View of looking upstream at TR2-1a.

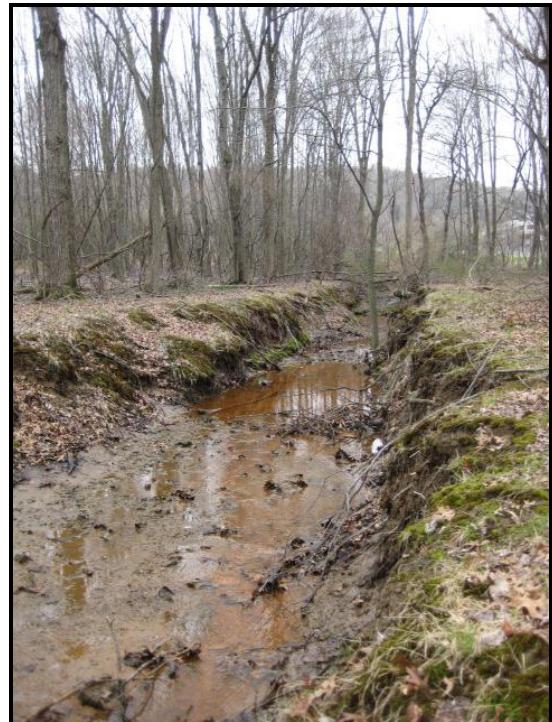
The site is located within a tributary to Reach MS3. The stream originates from Basin 5 within the commercial complex and drains through a wooded area. The channel is currently unstable and is incised well below the root horizon. Channel banks are nearly vertical and are up to 5 feet high. The stream channel assumes pool/riffle bed morphology, but deposition from bank erosion is evident with numerous point bars. Due to these conditions, stream habitat is poor.

View downstream in TR5-1.

The proposed project consists of restoring floodplain access and improve in-stream habitat. Retrofit of Basin 5 (Project 2) will improve management of stormwater flows entering the channel. The installation of a constructed wetland at the head of the channel will also reduce peak flows and improve water quality. Floodplain areas will be lowered by three-to-four feet and replanted with native trees and shrubs. Root wads and placed woody debris piles will be installed to enhance in-stream habitat. Woody debris piles will be anchored to the stream bed and bank using Duckbill-type earth anchoring systems.

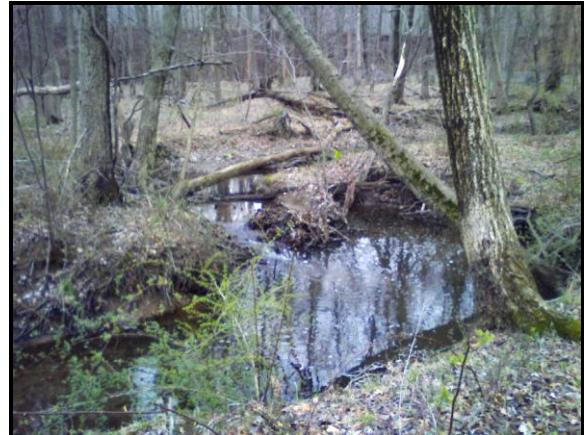
The site is located within TR4-1, which is tributary to the Silver Brook mainstem at the head of MS3. Much of this reach flows through a forested area, but is largely confined by I-287 to the south. The reach is also impacted by stormwater discharges from three flood control basins draining the urban residential area adjacent and to the north (see Project 1) and a stormwater outfall from I-287 entering the reach from the south. Upstream of the outfall, the stream is intact. Downstream of the outfall, the stream progresses through a section with excessive erosion to a headcut in the vicinity of Basin 3 (see Figure 3). The section of the reach downstream of the headcut to the Sand Spring Road crossing has characteristics of a depositional channel, reflecting the sediment load contributed by the eroding upstream section. Channel instability within this reach is likely due to exaggerated peak flows from under-managed stormwater. Improved management of stormwater (see Project 1) will reduce peak flows and channel energy and erosion. The headcut should be stabilized with an in-channel step pool to prevent the further upstream progression and to protect upstream sections which currently have no or only minor instability issues.

View upstream at headcut within TR4-1.

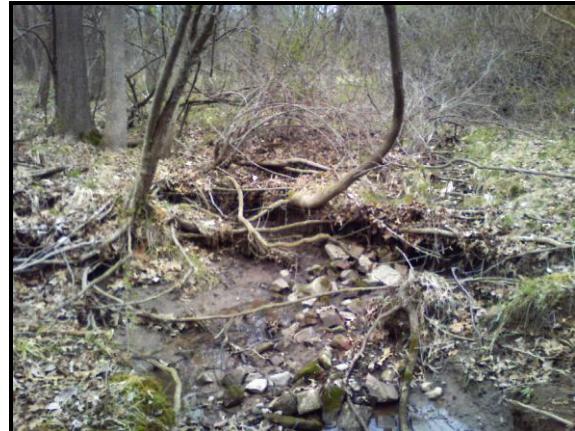
View upstream at headcut within TR5-2.

The proposed project will involve the construction of a constructed wetland at the headcut to dissipate concentrated flows from the existing detention basin and to stabilize the headcut. Floodplain areas will be lowered by one to two feet and replanted with native trees and shrubs, mitigating effects of recent incision and promoting connection of the channel with its floodplain.

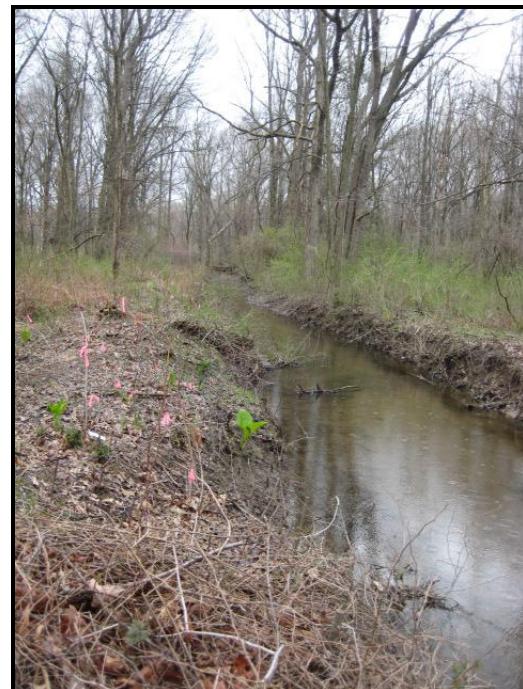
View looking downstream within MS3.

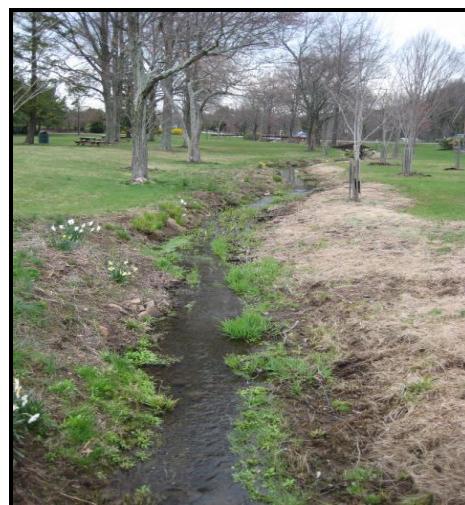
View looking downstream at TR1-2 within Bayne Park (Site 7d).

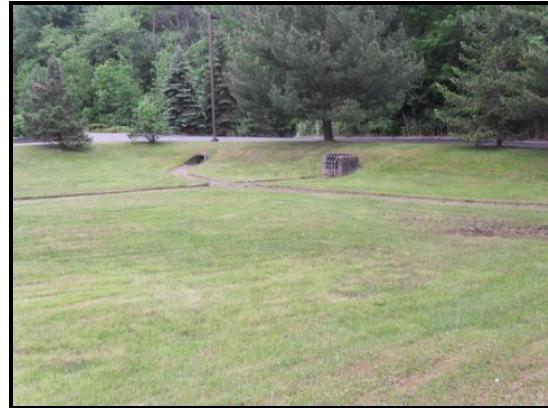
View of Basin 24.

The proposed project will increase the retention capacity of the basin by increasing the depth and modifying the outlet structure. The retrofit will involve reconfiguring the lower outlet structure orifice at an elevation higher than the current outlet to increase ponding depth for the water quality storm. The upper outlet structure orifice will be redesigned, as needed, to provide effective management larger storm events. The flow path of stormwater within the basin will be increased, and the removal of particulates will be enhanced with the installation of sediment forebays at each inlet structure. Replanting the basin floor with native species will increase evapotranspiration and provide pollutant uptake and slower flows.

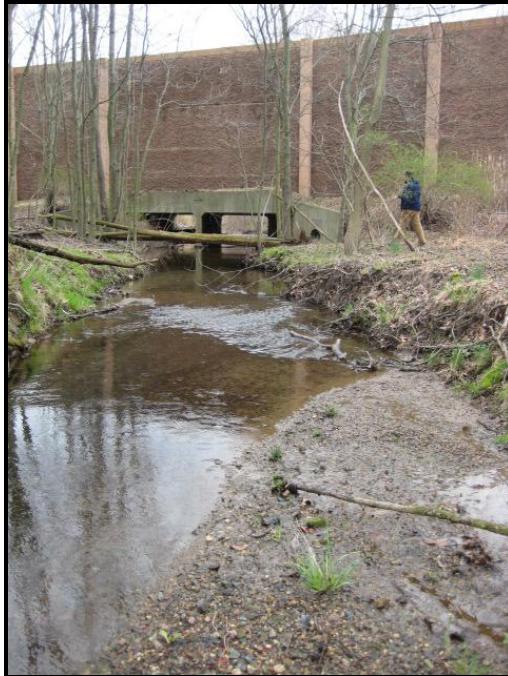
Photograph 1: View looking downstream at I-287 crossing over MS3.
The culvert is typical of I-287 stream crossings.

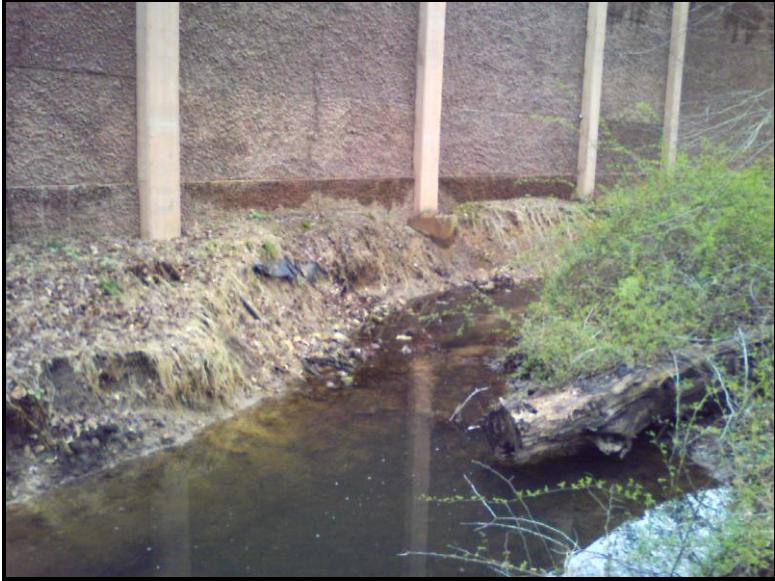
Photograph 7: View looking upstream at TR4-1 showing erosion along an outer bend exposing structural support of the I-287 sound barrier wall.

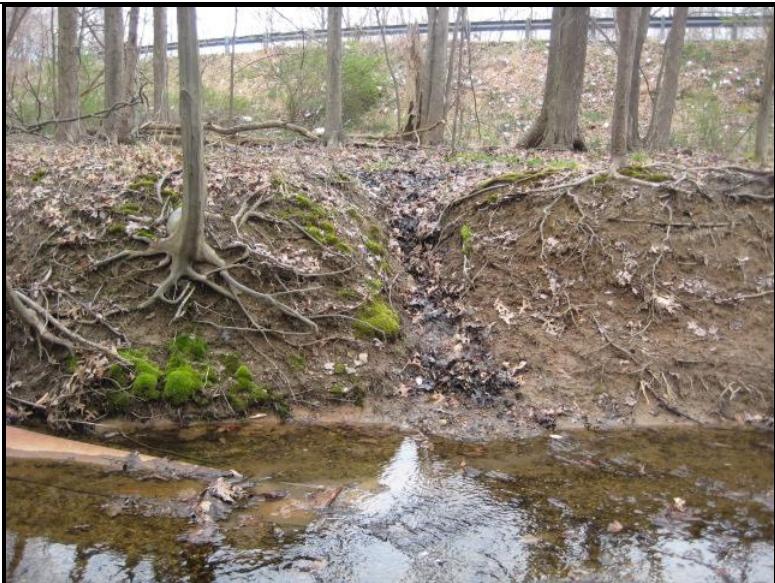
Photograph 8: View of a perched floodplain terrace and small channel dropping 2-3 feet to enter TR2-1.

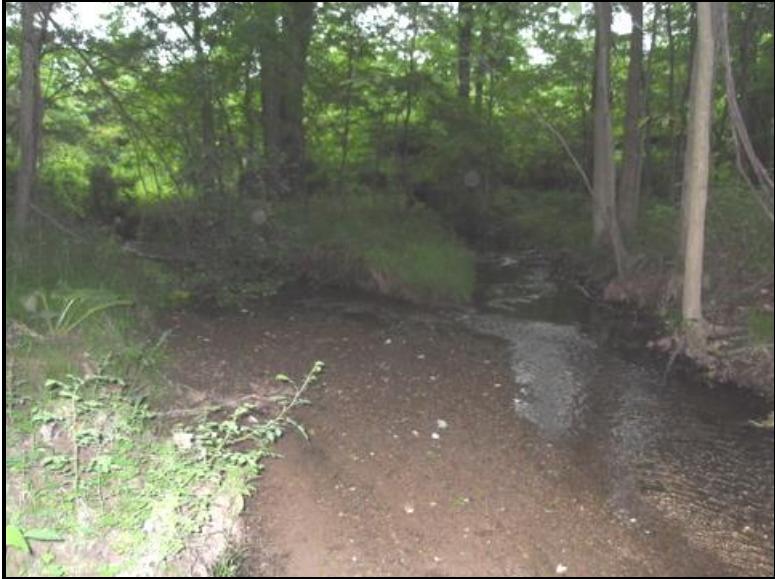
Photograph 9: View upstream of aggrading section of TR2-1. TR2-1a enters from the right side of the photograph.

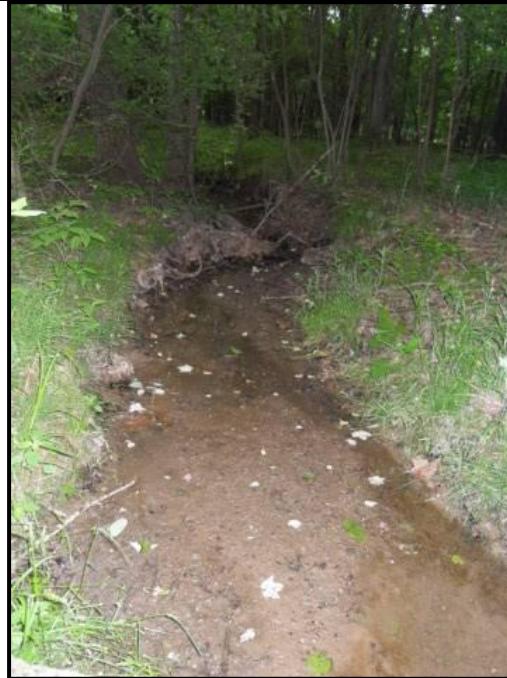
Photograph 10: View upstream of aggrading section of TR2-1a.

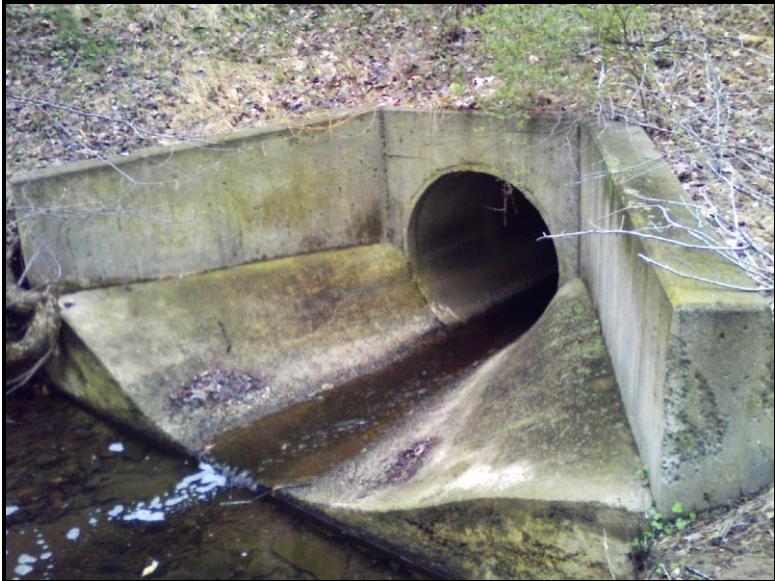
Photograph 12: View of an outfall delivering stormwater runoff from I-287 directly to TR4-1.
