**The Loantaka Brook Watershed Report
EPA Grant Number: X-97267701**

Prepared by:
Princeton Hydro, LLC
Suite 1, 1108 Old York Rd.
P.O. Box 720, Ringoes, NJ 08551
(908) 237-5660
ssouza@princetonhydro.com

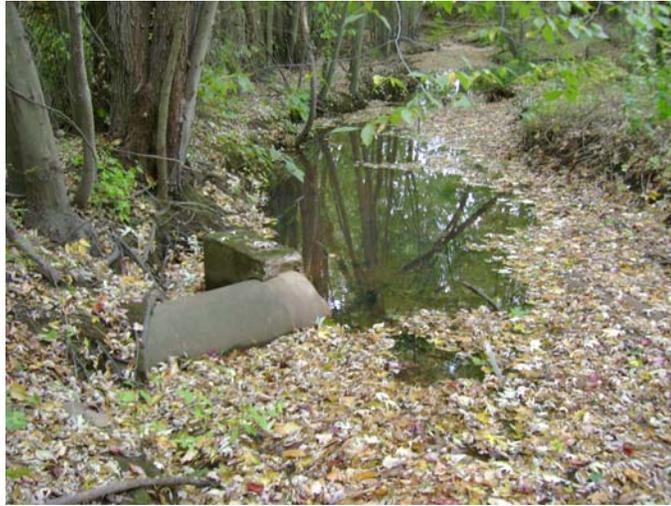
- High stormwater flows from upstream sources has contributed to eroding the streambank behind the headwall and discharge pipe for the 18” outfall that services the Woodland Elementary School, exposing 1-2 ft of pipe behind the headwall. It was documented during one of the site inspections conducted during this study that the headwall has been broken in half. It was unclear whether the Township is removing this headwall while in the process of retrofitting the outfall.
- Sediment bar deposition is evident immediately downstream of each outfall indicating the storm runoff provides significant sediment loading to Loantaka Brook, from each of these outfalls. The 48” and 60” outfall servicing Dorado Avenue, Village Drive and Johnston Avenue had the largest sediment depositions.

Photograph 5.1: Woodland Elementary School Outfall with broken headwall and exposed discharge pipe, October 22, 2008.

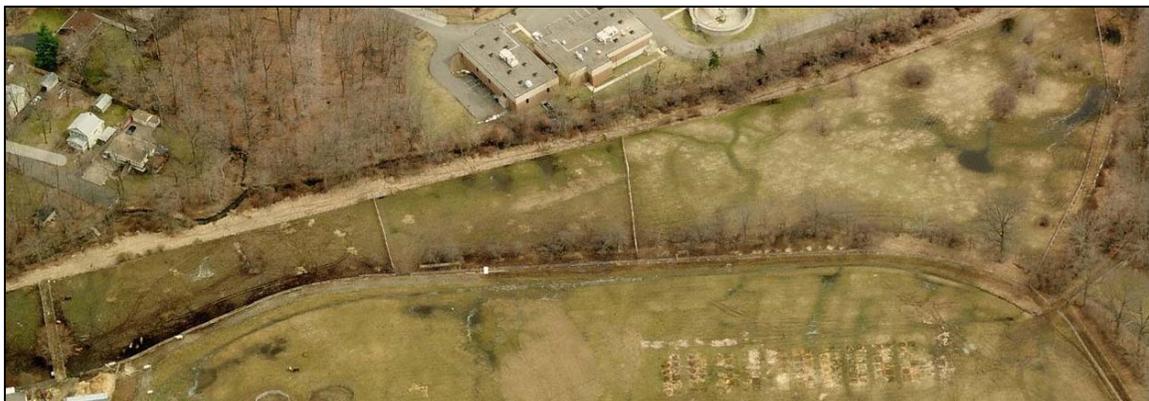
The land along the western side of Loantaka Brook is a relatively flat, low-lying area which is currently mapped as “Managed Wetlands (Modified)” according to the latest NJDEP wetlands data for Morris County, because they continue to be used as pasture land. No critical wildlife areas are located in the vicinity of the proposed treatment wetland. The NJDEP Landscape Area coverages are summarized in Map 3 of Attachment D. The flat topography of the site is ideal for the construction of a treatment wetland. As previously mentioned the area is currently used as a pasture and grazing area for horses as is shown in Photograph 6.1.

Photograph 6.1 Aerial View Looking East Of Paddock Area Along Loantaka Brook (Source: Microsoft Virtual Earth).
