Silver Brook Watershed Management Plan

July 15, 2009
NJ090193, #71088.0004

Prepared for:
The Great Swamp Watershed Association
568 Tempe Wick Road
Harding Township, NJ 07960

Prepared by:
AKRF, Inc.
100 Centre Blvd., Suite 102H/J
Marlton, NJ 08053

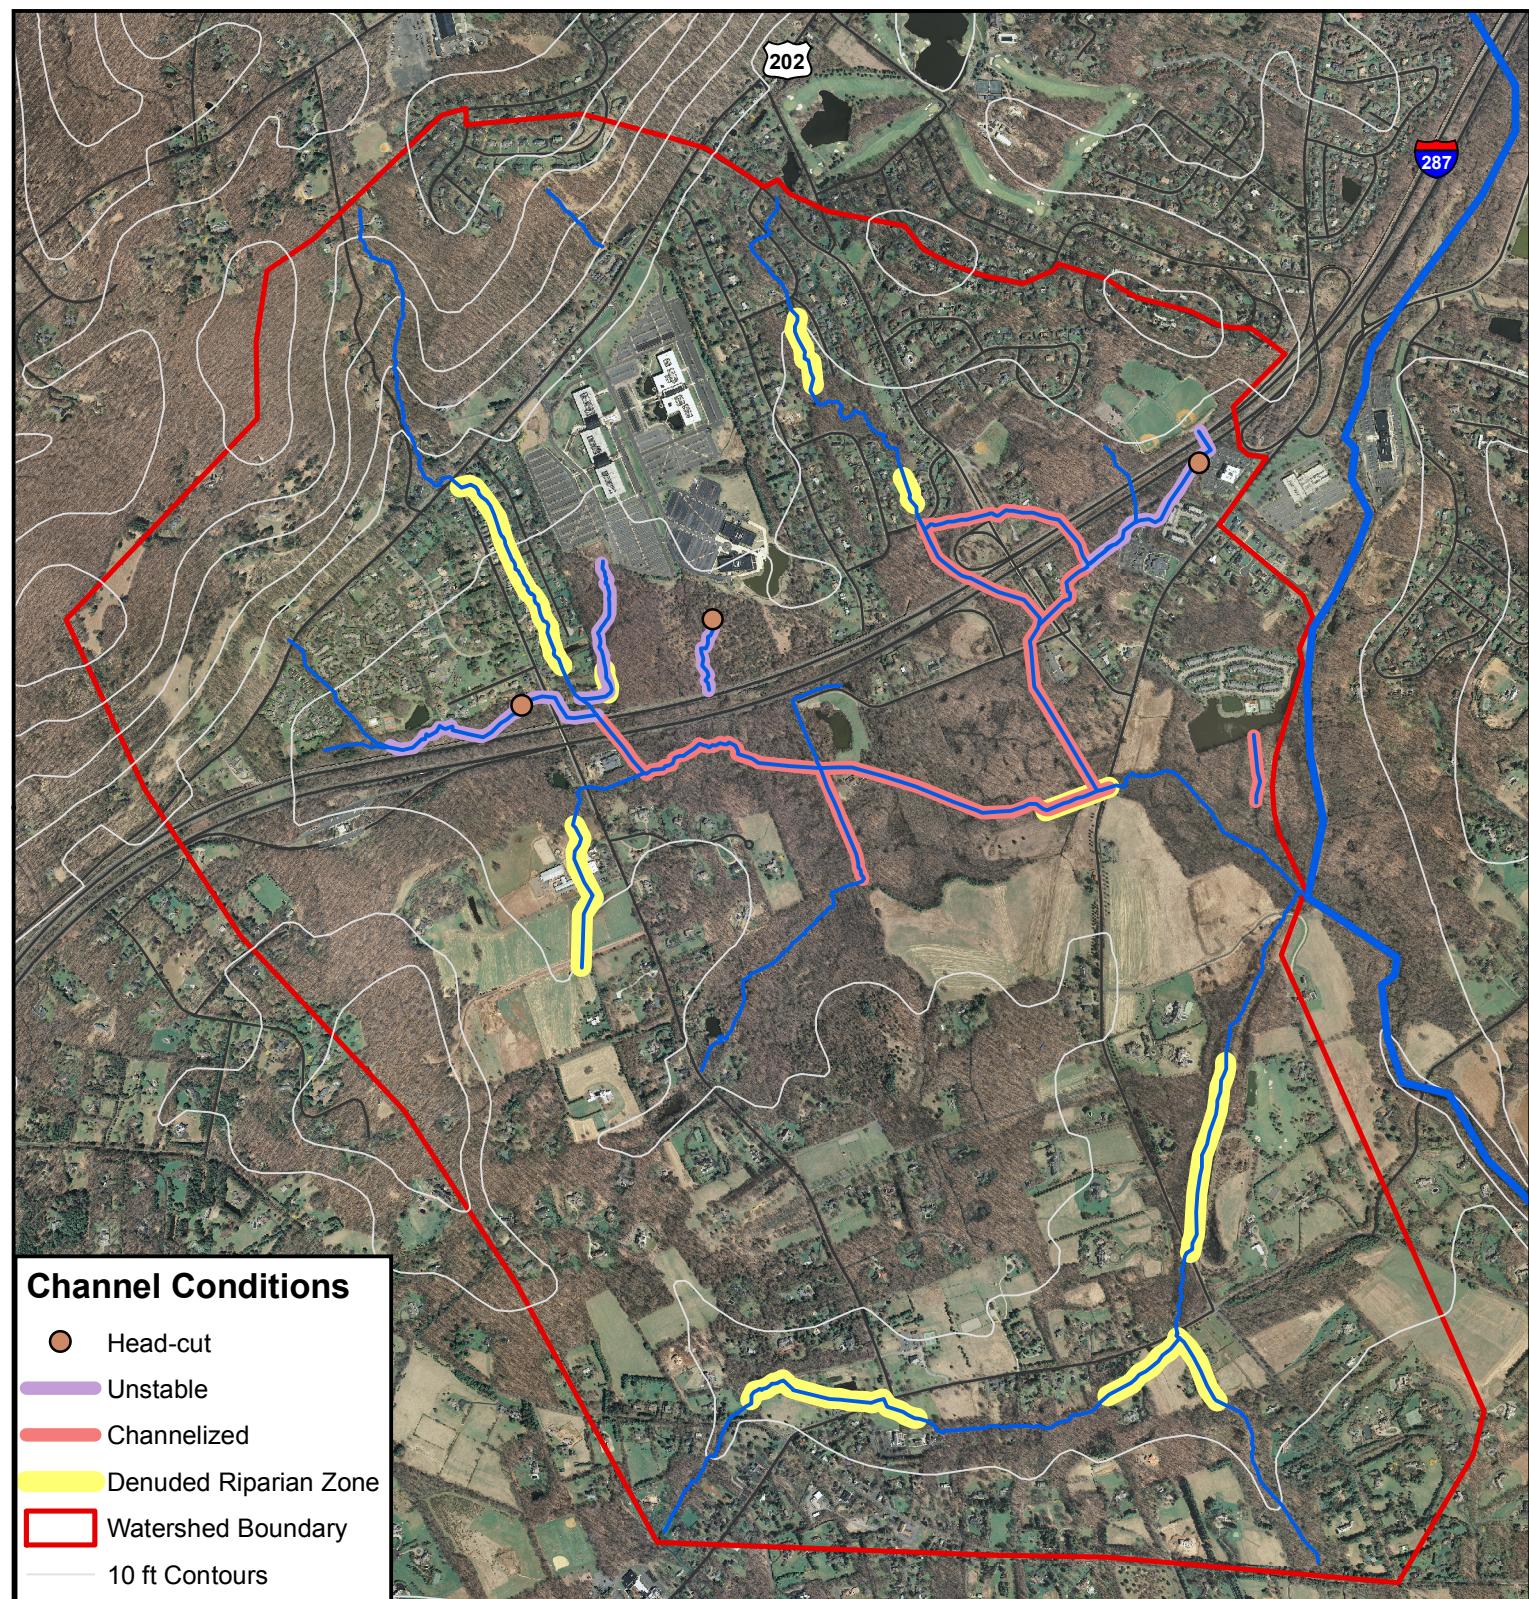
Figure 3
Silver Brook
Channel Corridor Conditions

A map showing the Silver Brook channel network is provided in Figure 2. The channel network has been divided into reaches for referencing purposes. Channel reaches on the mainstem of Silver Brook are given MS designations, while tributary channels are given TR designations. Reaches were delineated primarily on the basis of tributary junctions or stream crossings (e.g., bridges, dams, etc.). Areas within the channel network where channelization, instability, headcuts, and denuded riparian zones occur are shown in Figure 3 and described in further detail within this section.

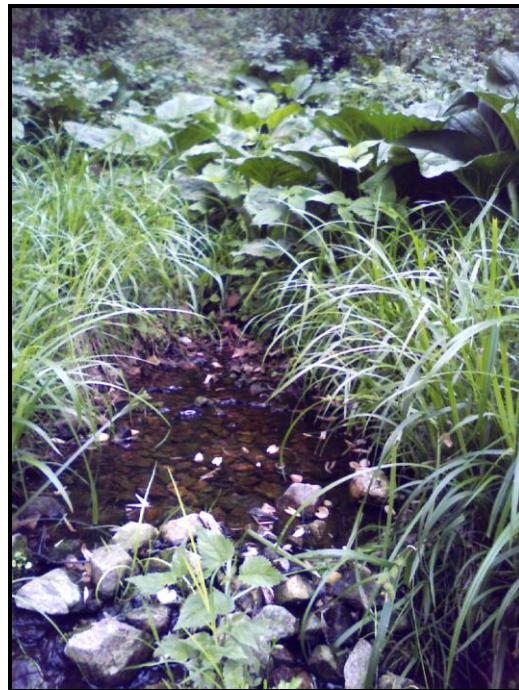
Photograph 2: View looking downstream at TR5-3.

The upper reaches of the Silver Brook channel network are high-gradient or moderate-gradient channels. Stream reaches running through high-gradient, confined valleys (MS5 and TR5-3) have relatively straight channels that assume step-pool bedforms (Photograph 2). These segments cut through colluvial (loose, slope-derived) material, have cobble-dominated substrate, few meanders and steep banks. Upstream reaches running through moderate-gradient and largely unconfined valley segments (TR4-1, TR4-2, and TR1-3) are meandering channels with step-pool or plane-bed bedforms dominated by a combination of gravel- and sand-sized materials (Photograph 3). These reaches are typically shallow with few pools, low banks and a large accessible floodplain. Although erosion of outer bends and deposition of sediment on point bars is natural, excessive bank and bed erosion in these reaches is likely the result of an altered flow regime due largely to the introduction of unmanaged stormwater. TR1-3, TR4-2, and the upper portions of TR4-1 have characteristics expected of largely undisturbed systems; however downstream sections of TR4-1 display regions of inner bank erosion, incision, and deposition of fine materials.

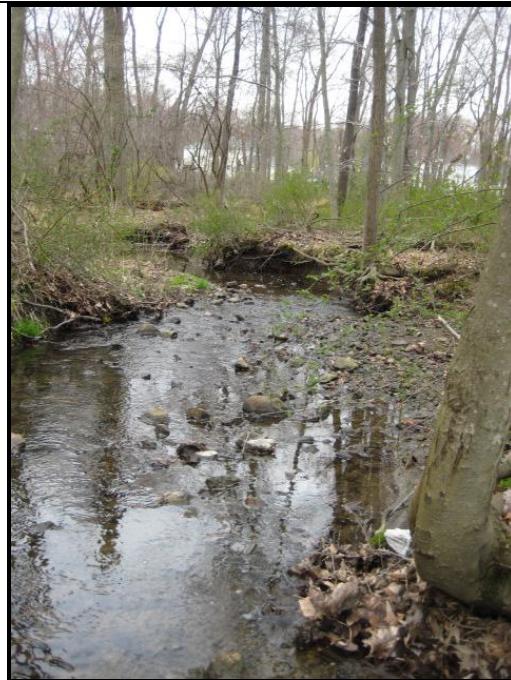
Photograph 4: View looking downstream at TR2-2.

Mid-network reaches flow through unconfined, moderate-gradient valleys and typically assume a meandering form (MS4, TR1-2, TR2-2, TR2-1a, TR3-2, and TR5-1). Bedforms are predominantly riffle/pool or plane-bed and are dominated by cobble and gravel substrates (Photograph 4). Although these reaches are not naturally confined and have wide accessible floodplains, most flow through areas that impose artificial restrictions. Private homes, roads, bridges, and maintained fields constrain the lateral movement of the channels in reaches MS4, TR1-2 and TR2-2. Reaches TR3-2, TR2-1a and TR5-1 flow through forested terrain and are accordingly less laterally confined.
