## Test Pit Observations and Depth of Waste

Rolling Knolls Landfill Superfund Site  
Chatham, New Jersey

Figure  
2-2

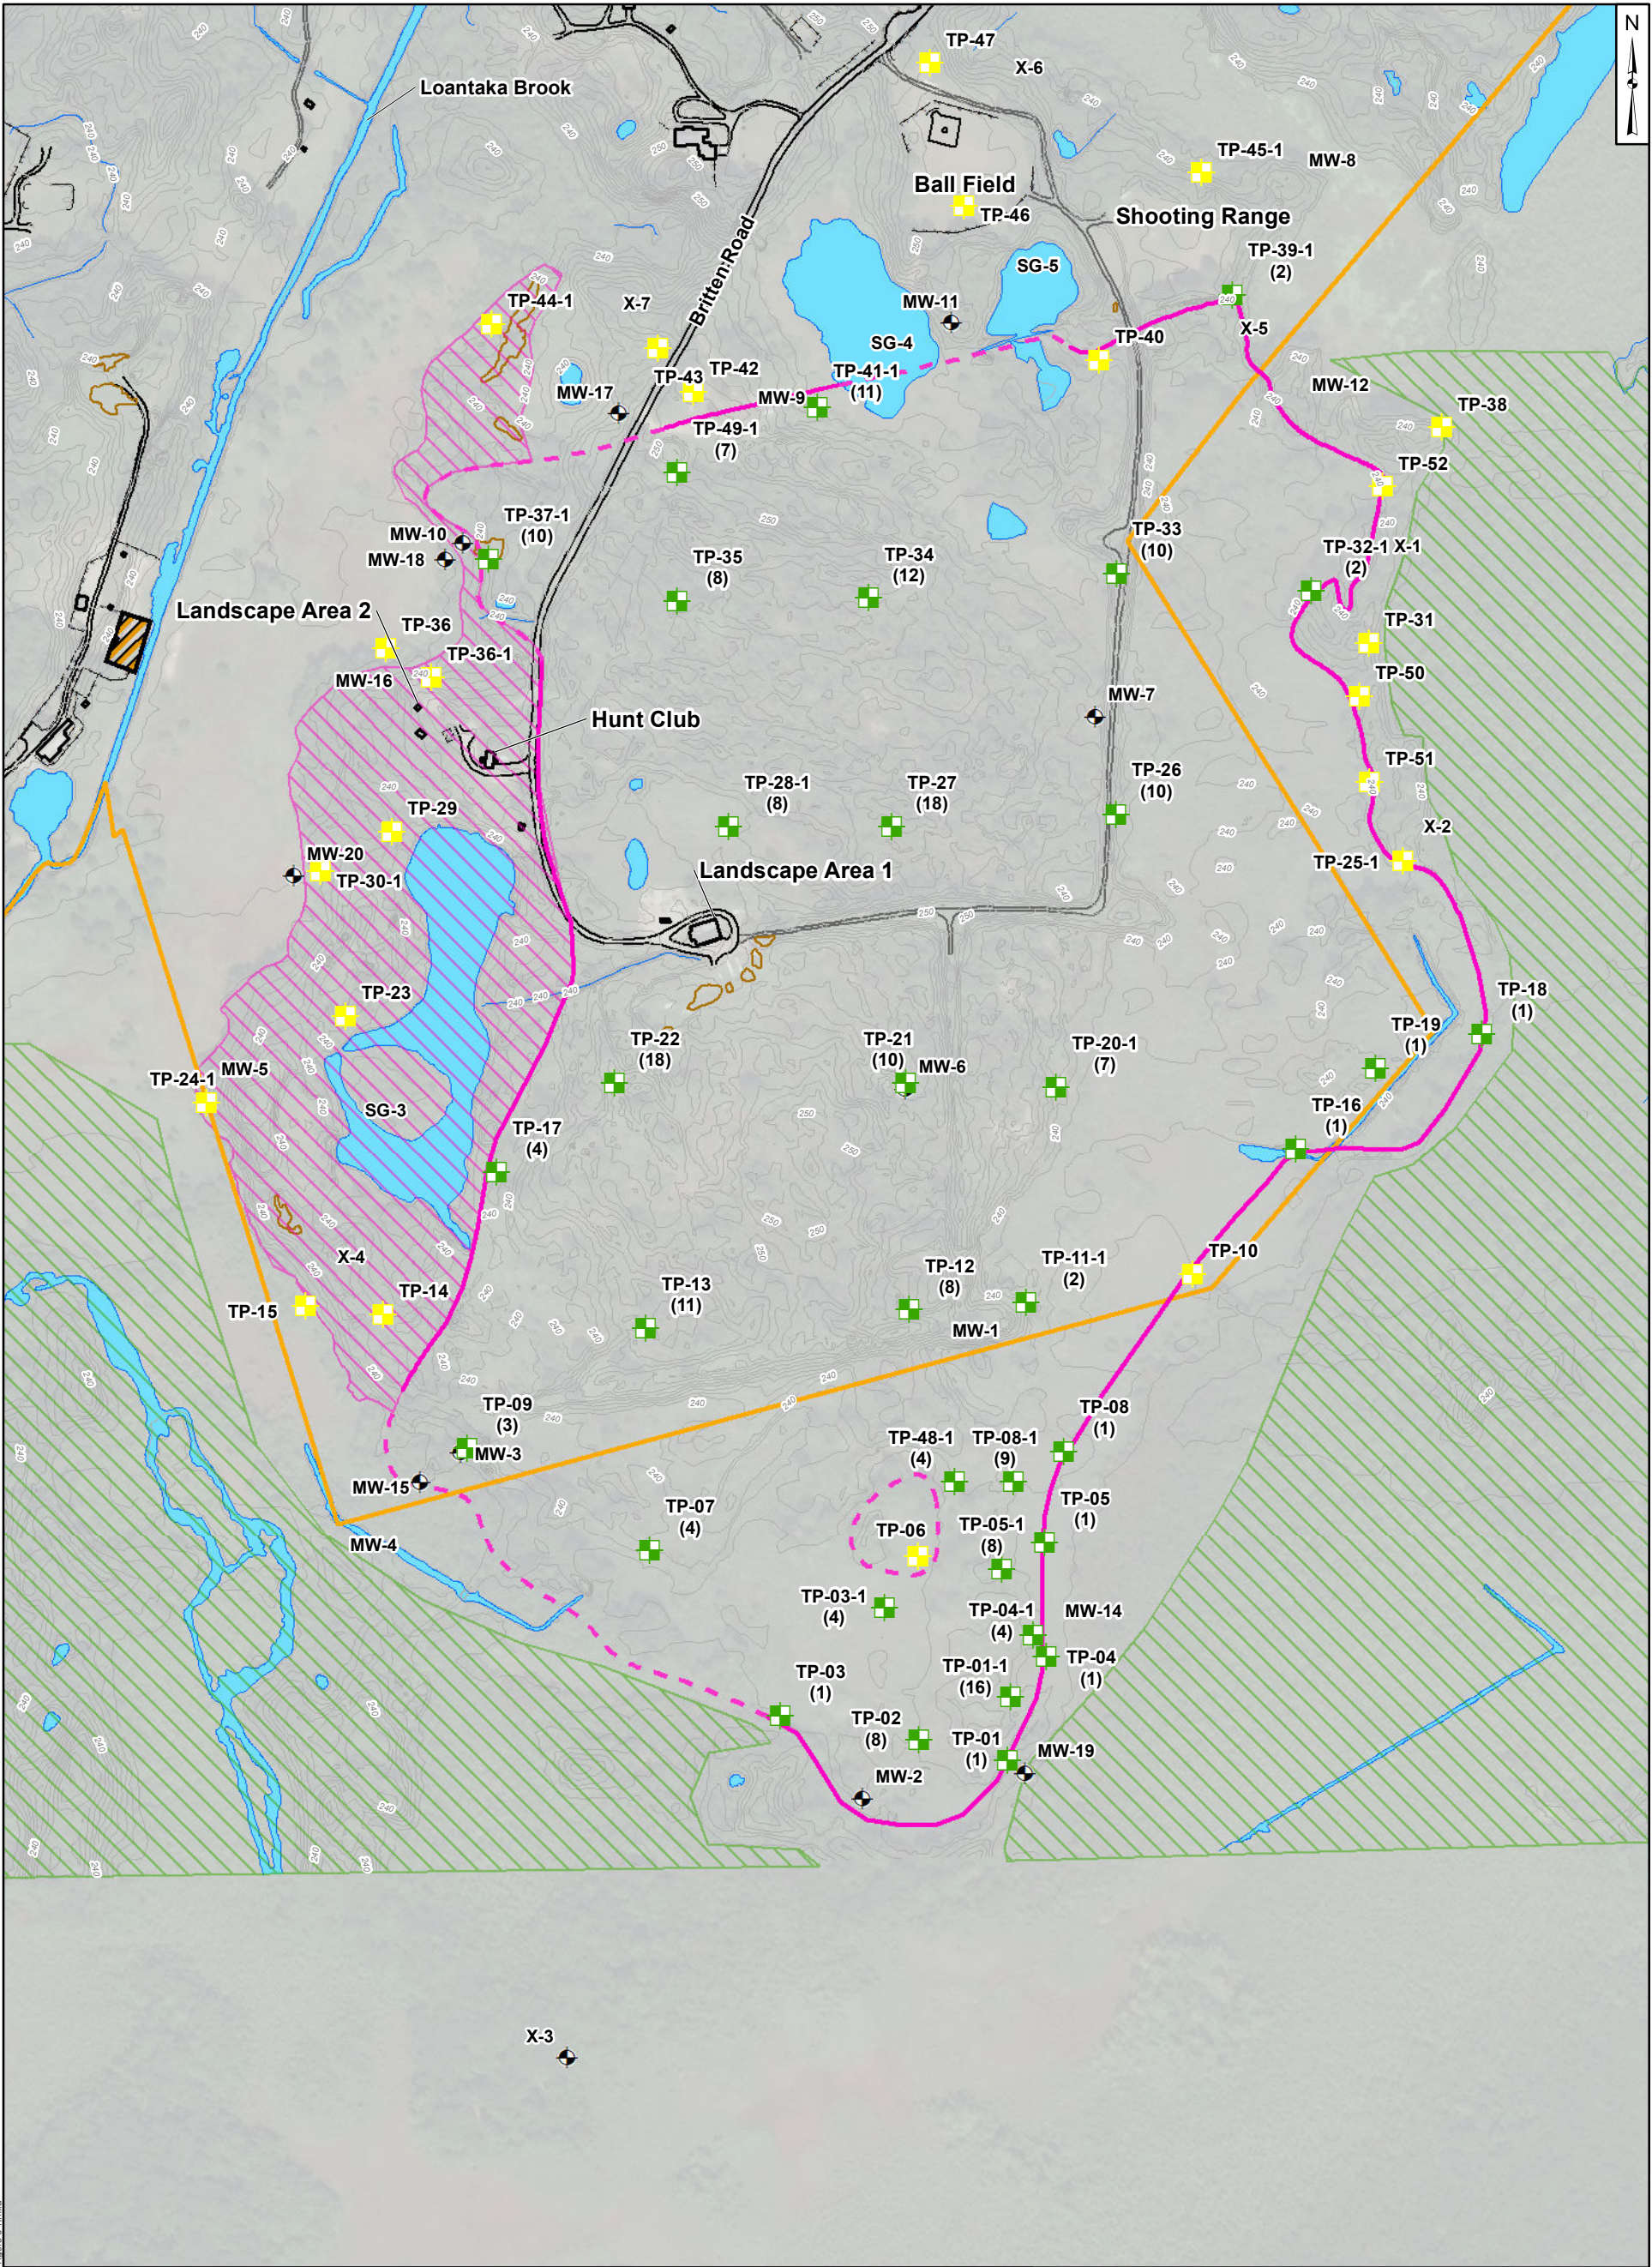
Site Plan created from Arcadis CAD drawings received December 2015.  
Aerial imagery accessed via ArcGIS Online and provided by the United States Department of Agriculture on 11 February 2021. Image is dated 31 July 2015.
